Contract #: 04-0120F4Cty: SF/ALA Rte: 80 PM: 13.2/13.9File #: 99.28**WELDING INSPECTION REPORT****Resident Engineer:**Siegenthaler, Peter**Address:** 333 Burma Road**City:** Oakland, CA 94607**Report No:** WIR-019189**Date Inspected:** 11-Jan-2011**Project Name:** SAS Superstructure**OSM Arrival Time:** 700**Prime Contractor:** American Bridge/Fluor Enterprises, a JV**OSM Departure Time:** 1900**Contractor:** Zhenhua Port Machinery Company, Ltd (ZPMC)**Location:** Shanghai, China**CWI Name:** N/A**CWI Present:** Yes No**Inspected CWI report:** Yes No N/A**Rod Oven in Use:** Yes No N/A**Electrode to specification:** Yes No N/A**Weld Procedures Followed:** Yes No N/A**Qualified Welders:** Yes No N/A**Verified Joint Fit-up:** Yes No N/A**Approved Drawings:** Yes No N/A**Approved WPS:** Yes No N/A**Delayed / Cancelled:** Yes No N/A**Bridge No:** 34-0006**Component:** OBG Trial Assembly**Summary of Items Observed:**

Orthotropic Box Girder (OBG) at Trial Assembly Areas

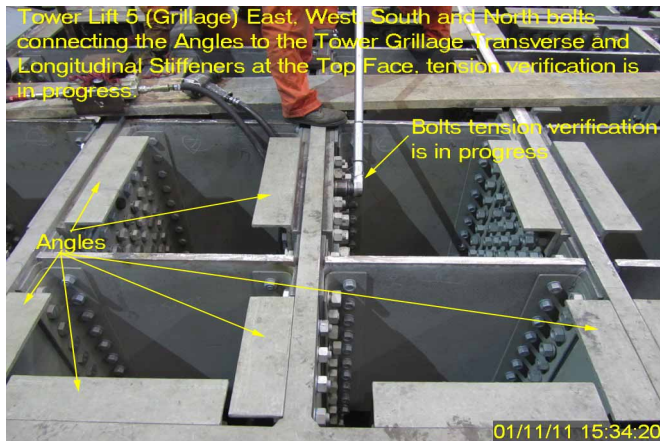
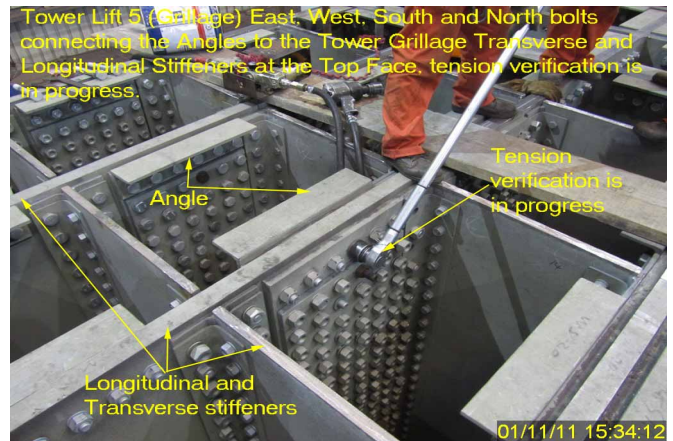
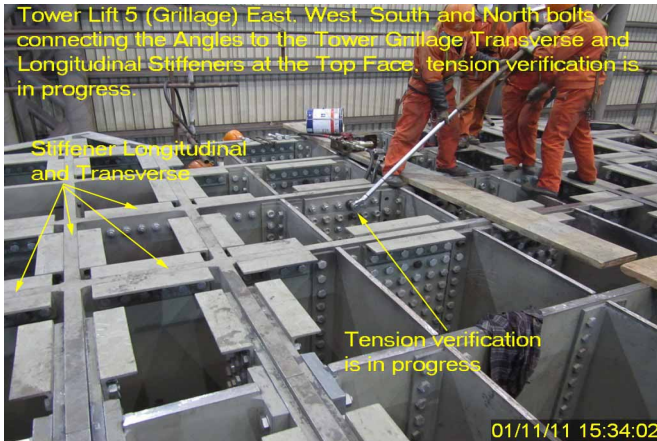
This QA Inspector witnessed final bolt tension verification on bolts connecting the Angles to the Tower Grillage East, Transverse and Longitudinal Stiffeners at the Top Face. Inspected the bolt tensioning on a random basis and found the tension to be in general compliance. Inspection was performed against the Notification No. 00608 Dated January 11, 2011.

This QA Inspector witnessed final bolt tension verification on bolts connecting the Angles to the Tower Grillage West, Transverse and Longitudinal Stiffeners at the Top Face. Inspected the bolt tensioning on a random basis and found the tension to be in general compliance. Inspection was performed against the Notification No. 00608 Dated January 11, 2011.

This QA Inspector witnessed final bolt tension verification on bolts connecting the Angles to the Tower Grillage North, Transverse and Longitudinal Stiffeners at the Top Face. Inspected the bolt tensioning on a random basis and found the tension to be in general compliance. Inspection was performed against the Notification No. 00608 Dated January 11, 2011.

This QA Inspector witnessed final bolt tension verification on bolts connecting the Angles to the Tower Grillage South, Transverse and Longitudinal Stiffeners at the Top Face. Inspected the bolt tensioning on a random basis and found the tension to be in general compliance. Inspection was performed against the Notification No. 00608 Dated January 11, 2011.

Note: Please reference the pictures attached for more comprehensive details(for Tower Grillage (Lift 5) - East, West, North and South.
